DETAILED GEOLOGIC INVESTIGATION OF DAM SITES

State Virginia County Augusta Sec. T. R. Watershed Upper North River
 Subwatershed Little River Fund class FP Site number 77 Site group I Structure class C
 (FP 2, WP 1, etc.) Sprague & Henwood
 Investigated by Mack, T., Geologist Equipment used Case backhoe, coradrig Date 8-10-63
 (signature and title) (Type, size, make, model, etc.)

Drainage area size 16.01 sq. mi. 10,240 acres Type of structure Earth Fill Purpose Flood Prevention
 Direction of valley trend (downstream) South Maximum height of fill 93.0 feet Length of fill 685 feet
 Estimated volume of compacted fill required 557,105 yards

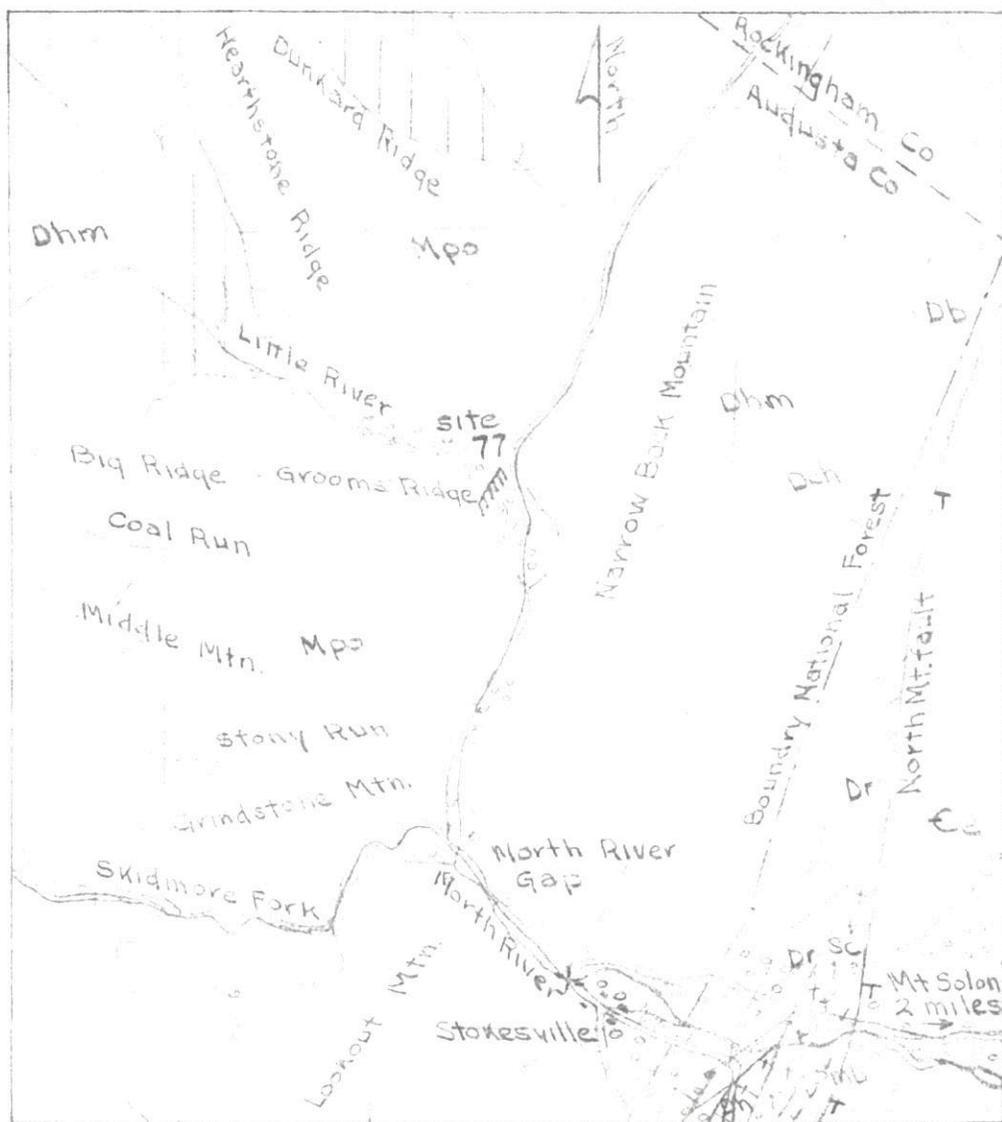
GEOLOGIC MAP* OF AREA SURROUNDING SITE NO. 77, UPPER NORTH RIVER W/S, AUGUSTA CO., VIRGINIA
 Butts, Charles, 1933, Geologic Map of the Appalachian Valley, Virginia: Va. Geol. Survey
 Bulletin 52 pt. 3

Scale 0 1/2 1 2
 scale 1 inch equals approximately one mile

Pocono sandstone and shale		Helderberg limy shale	
Hampshire red shale and sandstone		Clinch sandstone and quartzite	
Chemung shale and sandstone		Martinsburg shale	
Brallier shale		Elbrook limestone and dolomite	
Romney shale		Recent overlay boulders, cobbles & gravels

General geology of site: Site #77 is located in Augusta County in the George Washington National Forest. The bedrock present is part of the Price-Pocono formation which is the lowest formation of the Mississippian system present in Virginia. Approximately 500 feet of Price-Pocono formation lie below the rocks that occur at the centerline of the dam and the unconformity at the base of the Mississippian system. Below this unconformity is the Hampshire formation which is of upper Devonian age.
